## Site 174 Ebben Creek

Great Marsh Coastal Wetlands Restoration Plan  
Rapid Technical Assessment Site 174

# Great Marsh Coastal Wetlands Restoration Planning

## Rapid Field Assessment

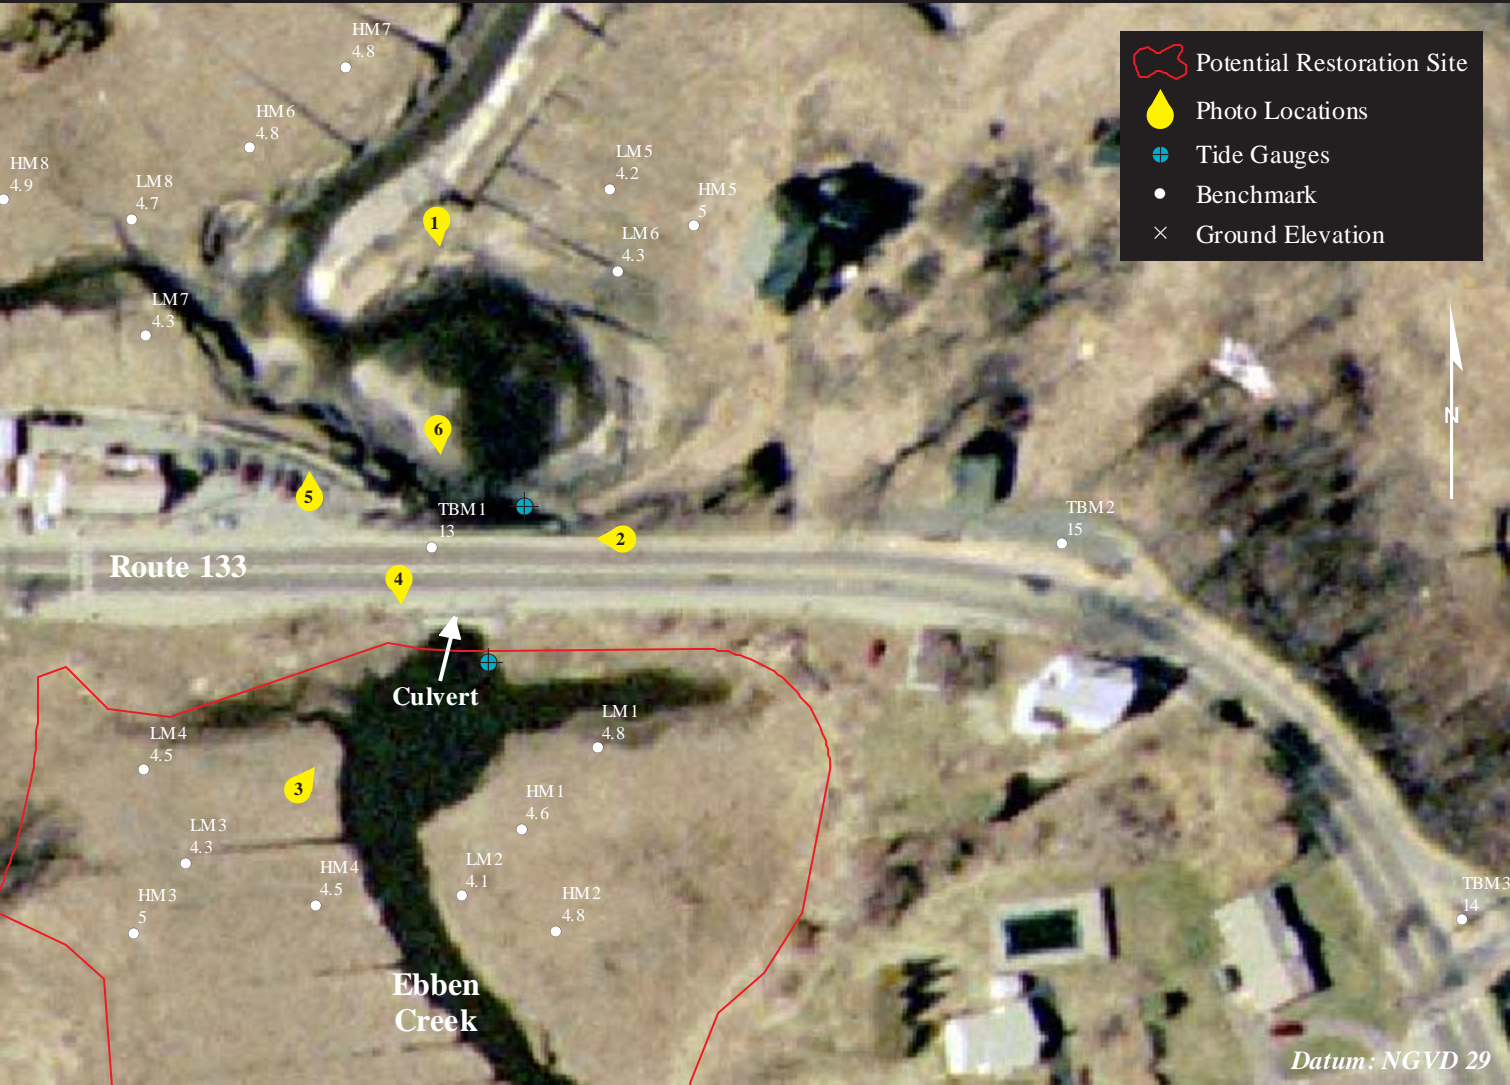
**Photo 1 - Downstream End of Roadway Crossing**

**Structure conditions:** Ebben Creek is conveyed under Route 133 via a 3 ft wide by 7 ft high granite block culvert. The granite blocks are supported by timber lagging and carry a concrete deck supporting the roadway. The upstream and downstream inverts and embankments are protected from scour by riprap. Beyond the riprap protection are significant scour pools. Inside the culvert there is some minor erosion around the timber lagging; however it is not severe enough to affect the structural integrity of the culvert. Overall the culvert is in fair condition and Route 133 is in good condition. The original age of the structure is unknown. The concrete deck was last replaced in 1934. Construction of a sewer line along Route 133 was recently completed and the roadway was repaved. There is approximately 4 ft of cover over the culvert which includes a number of underground utilities. The life expectancy of the culvert is estimated at 15 years. There are no known plans to replace the structure.

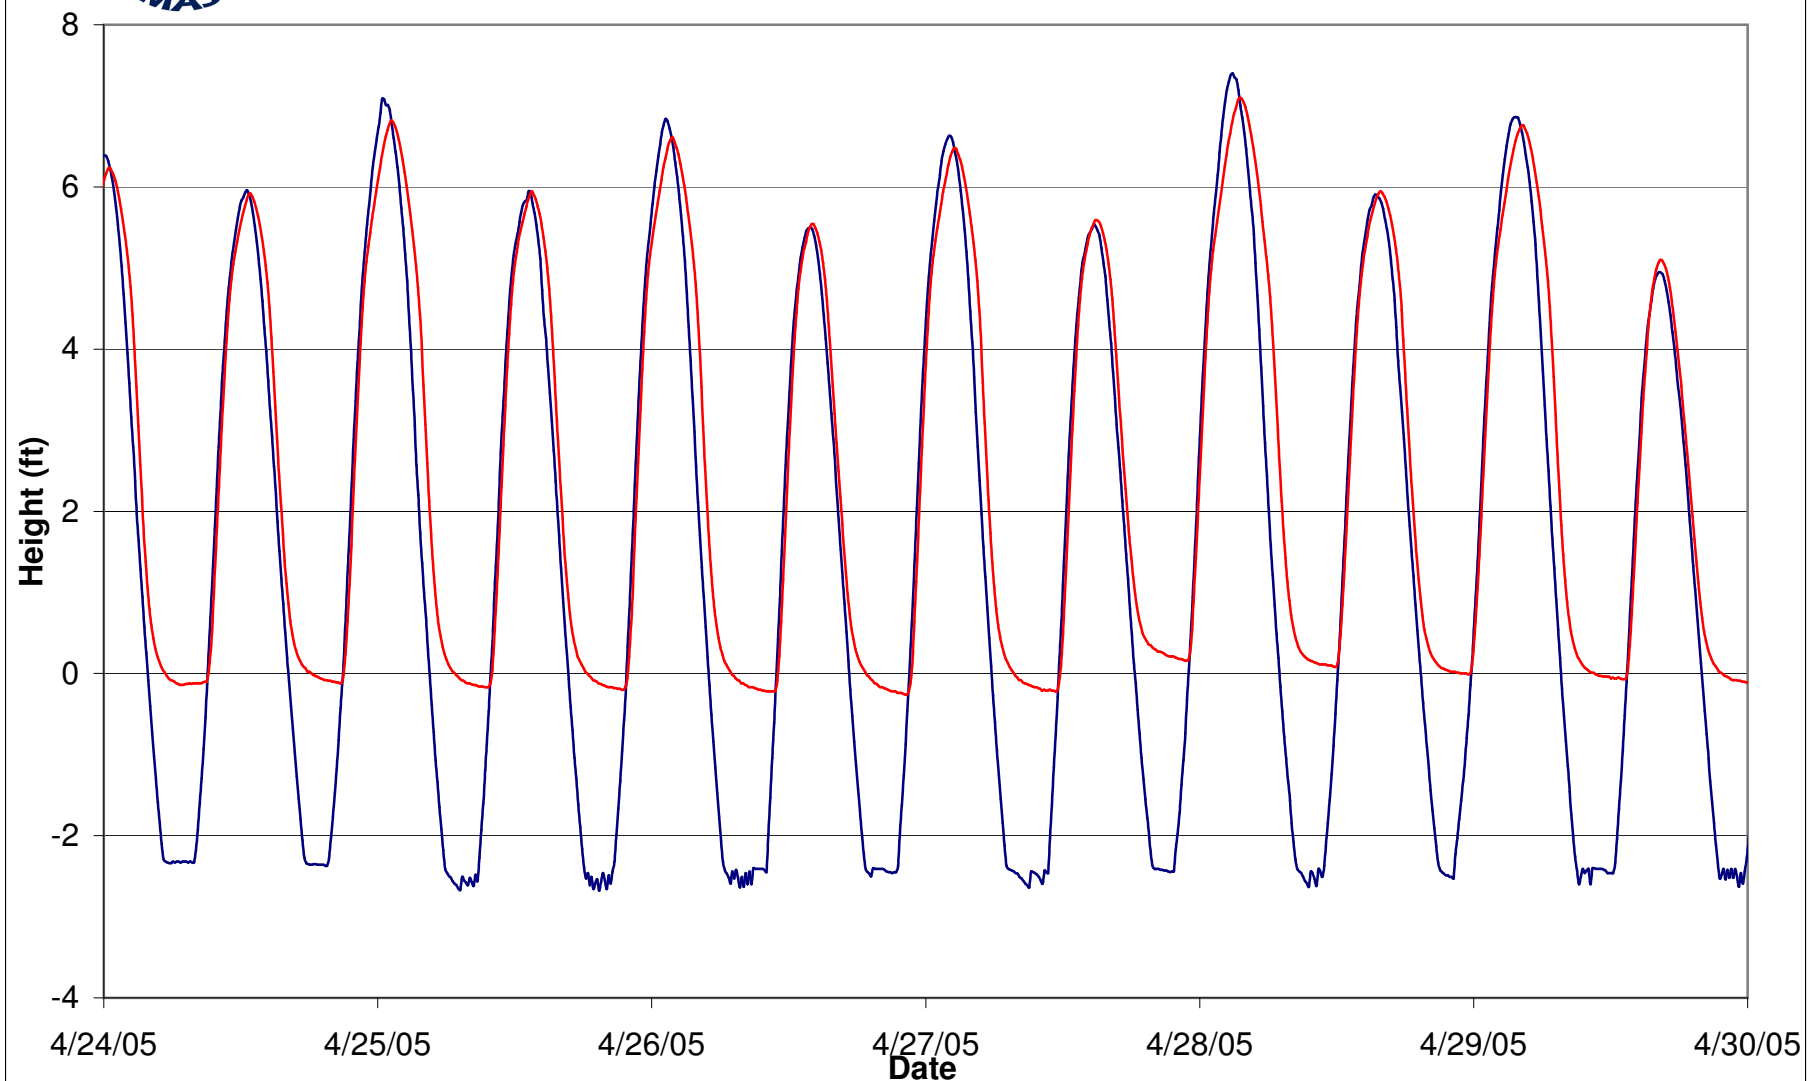
deployment, two tide gauges were installed: one upstream and one downstream of the Route 133 crossing over the creek. Results of the April/May deployment show a small restriction at the crossing which becomes more pronounced at the higher tides above 6 ft adjusted to NGVD. There were eight such occurrences out of 23 tidal cycles recorded during the deployment period. Tidal restrictions ranged from less than 0.1 to 0.3 ft and delays ranged from less than 10 to 47 min. The highest tide during the deployment period occurred on April 28 at 2:54 AM. The NVGD adjusted height downstream of the crossing was 7.40 ft. The upstream adjusted height was 7.10 ft and occurred at 3:31 AM. The restriction caused a tidal dampening of 0.30 ft upstream of the bridge and a delay of 37 minutes. The dampening amounted to less than 3% of the total tidal prism recorded at the downstream gauge. Longer delays of 47 min occurred on April 25 and 29 but with slightly smaller restrictions of 0.27 and 0.10 ft, respectively. Measured salinities were 0.9 ppt both up and downstream of the bridge during a slack tide condition.

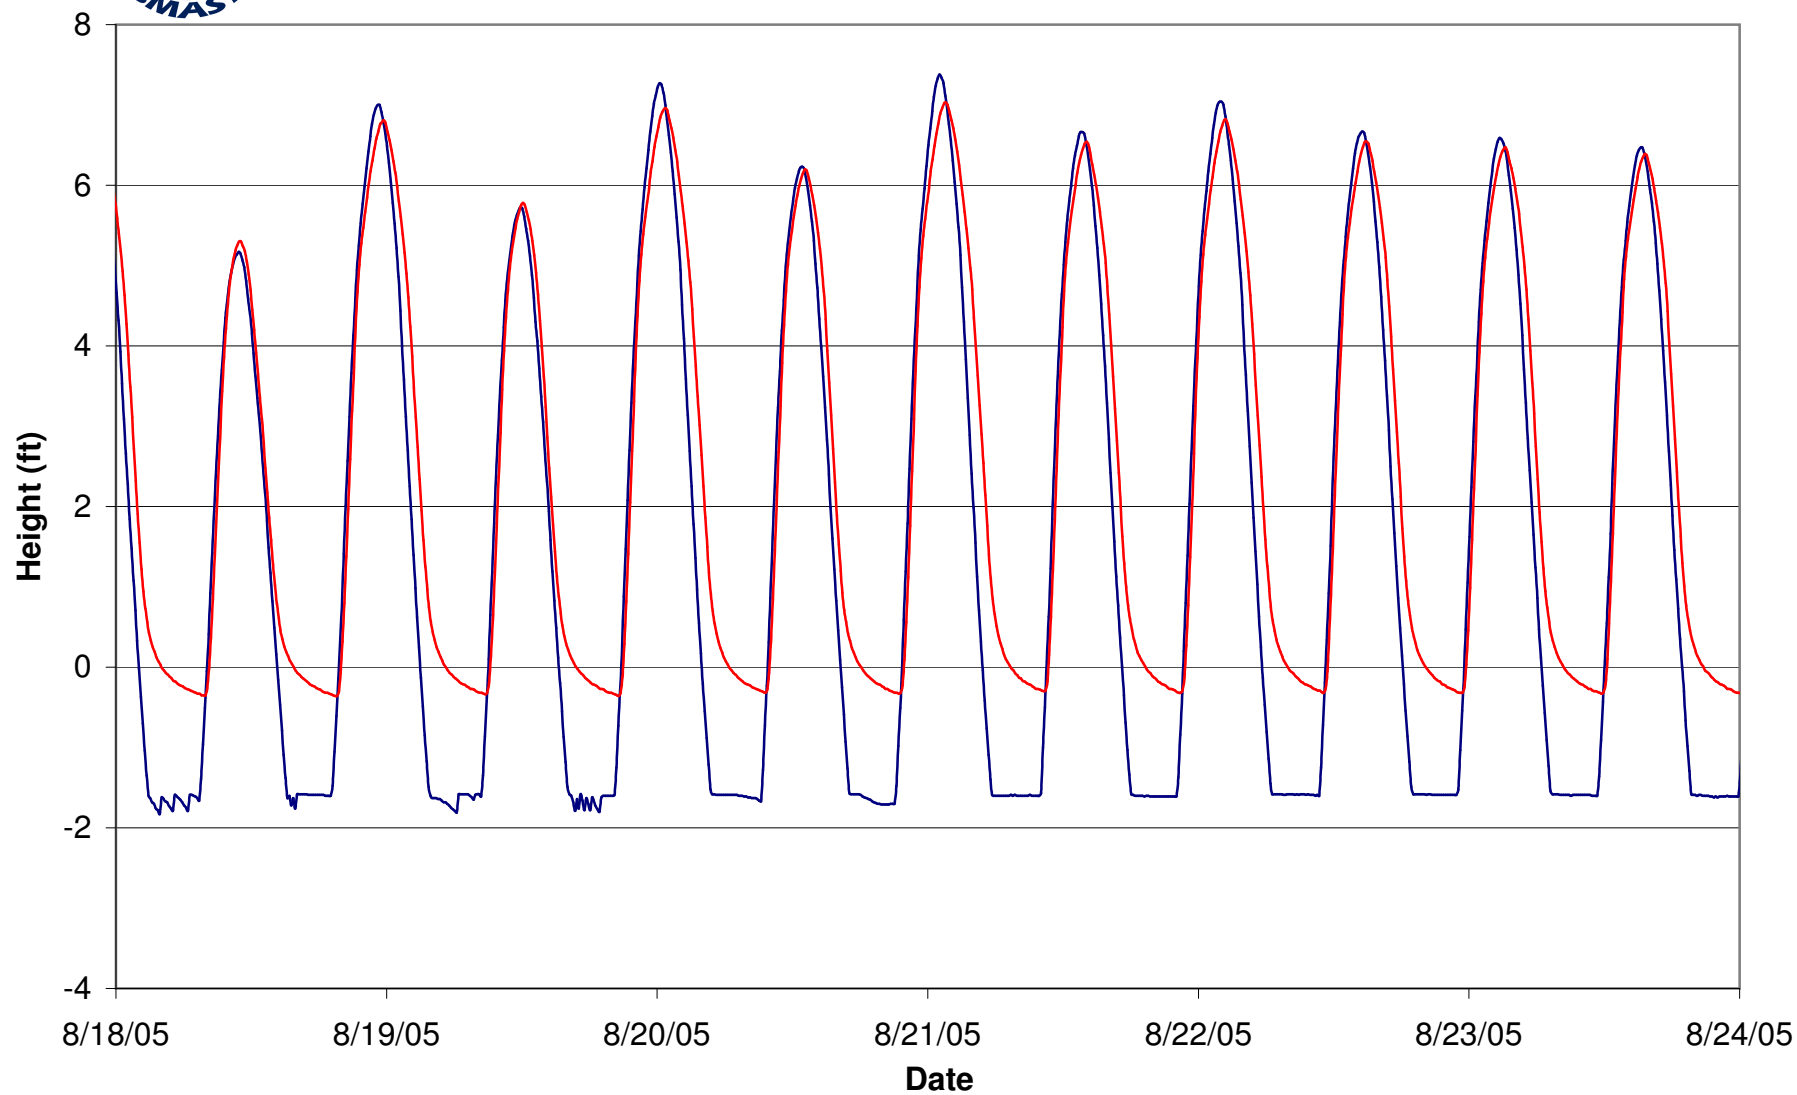
Results of the August/September deployment show a similar restriction at the crossing which becomes more pronounced at the higher tides above 6 ft NGVD. There were 11 such occurrences out of 51 tidal cycles recorded during the deployment period. Tidal restrictions ranged from less than 0.1 to 0.35 ft and delays ranged from less than 10 to 33 min. The highest tide during the deployment period was on August 21 at 1:03 AM. The NVGD adjusted height of the water downstream of the bridge was 7.30 ft. The upstream adjusted height was 7.03 ft which occurred at 1:36 AM. The restriction caused a tidal dampening of 0.35 ft upstream of the bridge and a delay of 33 minutes. The dampening amounted to less than 3.9% of the total tidal prism recorded at the downstream gauge.
